COBIGUA PORT – PUERTO BARRIOS (GUATEMALA)

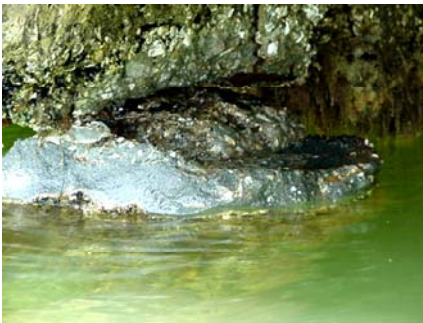
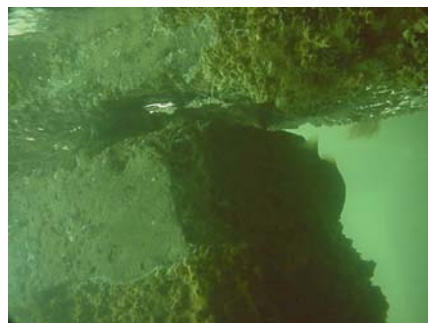
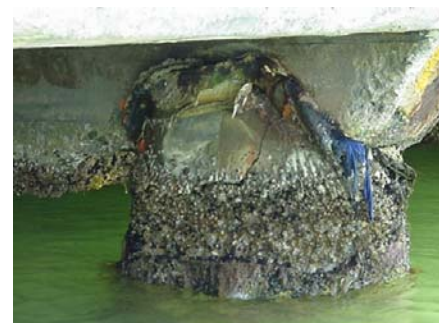
Damages were mostly caused by breakings between concrete piles and platform with wrecked concrete and heavy damages to the steel reinforcement. Many attempts were carried out by the Port Authorities to repair the damaged concrete piles with traditional systems but without results.

Typical ruptures between concrete piles and platform

Repair works varied from replacement by welding of the damaged reinforcement, filling up the cavities between platform and piles heads and reconstruction of the missing concrete above and under water using some 20.000 kilos of Subcom T.260, a thixotropic, solventless, two packs, epoxy mastic designed for underwater and other wet applications. Other special Sinit material like # 108 Mortar, thixotropic, rheoplastic, non-segregating, non-shrink, high strength mortar, with high bond to steel and concrete, and L.A. 2S, two-component, low-viscosity, solventless, liquid epoxy adhesive were also used to complete the work.

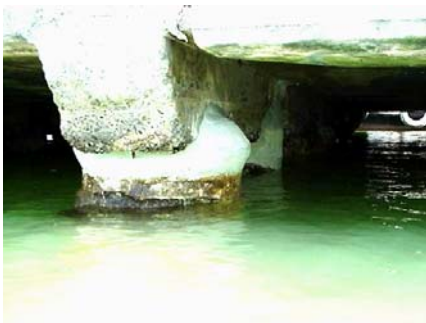
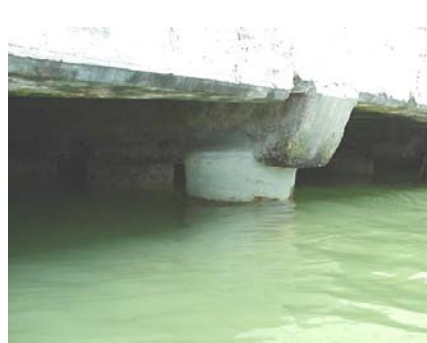
View of the rehabilitation with Subcom T.260 replacing concrete between piles and platform
