COBIGUA PORT – PUERTO BARRIOS (GUATEMALA)

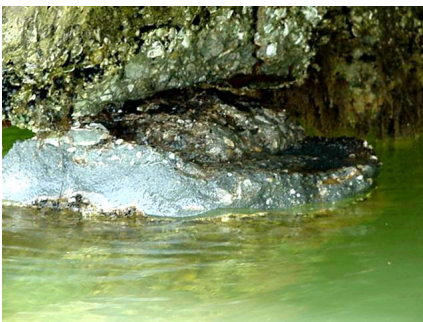
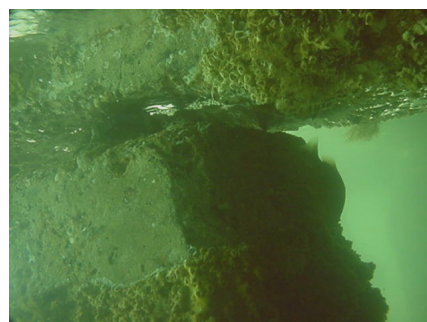
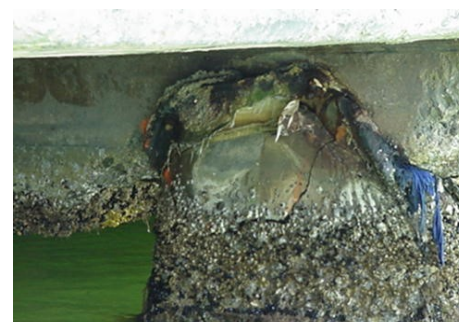
Damages were mostly caused by breakings between concrete piles and platform with wrecked concrete and heavy damages to the steel reinforcement. Many attempts were carried out by the Port Authorities to repair the damaged concrete piles with traditional systems but without results.

Typical ruptures between concrete piles and platform

Repair works varied from replacement by welding of the damaged reinforcement, filling up the cavities between platform and piles heads and reconstruction of the missing concrete above and under water using some 20.000 kilos of Subcom T.260 (a thixotropic, solventless, two packs, epoxy mastic designed for underwater and other wet applications) and SUBCOM 150 (fluid underwater curing epoxy compound for pressure injection grouting or, mixed with selected aggregates, to form mortar for general repairs).

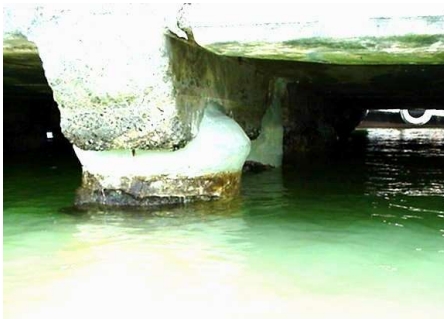
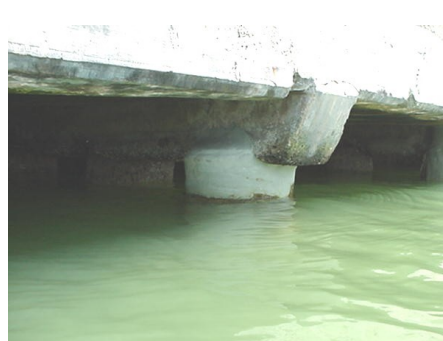
View of the rehabilitation with Subcom T.260 replacing concrete between piles and platform

Other utilised special Sinit materials: INJECTION 1 low viscosity injection resin, #108 MORTAR, thixotropic, rheoplastic, non-segregating, non-shrink, high strength mortar, with high bond to steel and concrete, and L.A. 2S, two-component, low-viscosity, solventless, liquid epoxy adhesive were also used to complete the work.
